# Hearthstone of Ellicott Mills Condominium, Inc.

Ellicott City, MD • July 28, 2022

At the direction of the Board that recognizes the need for proper reserve planning, we have conducted a *Full Reserve Study* of Hearthstone of Ellicott Mills Condominium, Inc. in Ellicott City, Maryland and submit our findings in this report. The effective date of this study is the date of our visual, noninvasive inspection, July 28, 2022.

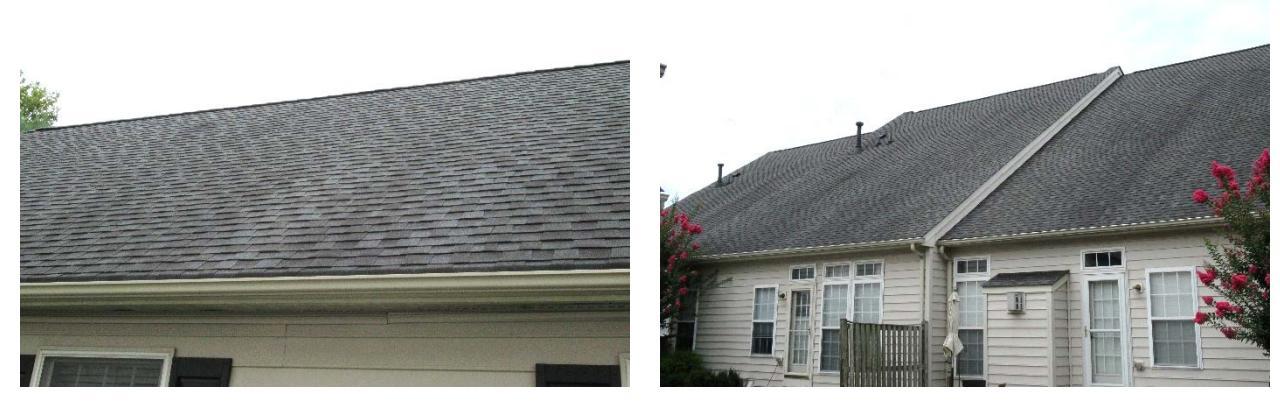
**Condition:** Varying conditions from good to fair overall with periodic previous repairs, curled shingles and granular loss evident from our visual inspection from the ground. Management and the Board reports a limited history of leaks and accelerated deterioration at the units along the west side of Evening Sky Court.

**Roof overview**

**Roofs overview**

**History:** Original; The Association has conducted roof repairs at a limited quantity of units to address leaks in recent years. The Association should conduct inspections of the roofs annually funded through the operating Budget. *Note: In 2022, the Association conducted an inspection by* Walter Brown Roofing *to assess the overall condition of each roof section. Based on the findings of the roof report and noted conditions, we defer replacement of the roofs until 2028.*

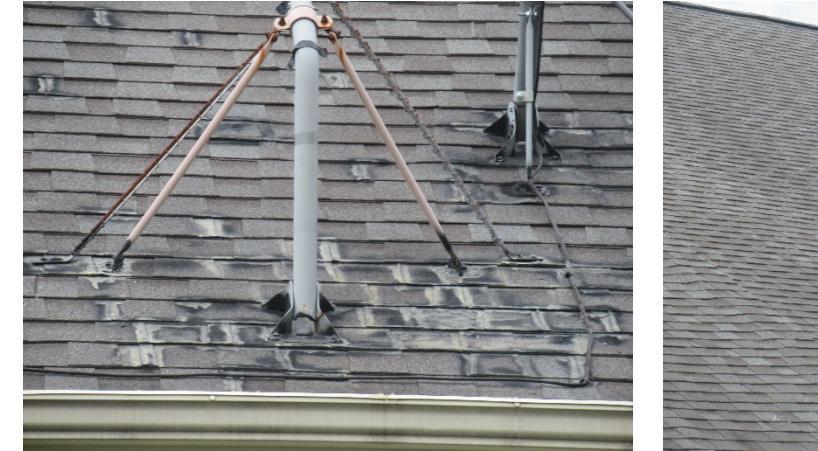
Granular loss

**Roof overview**

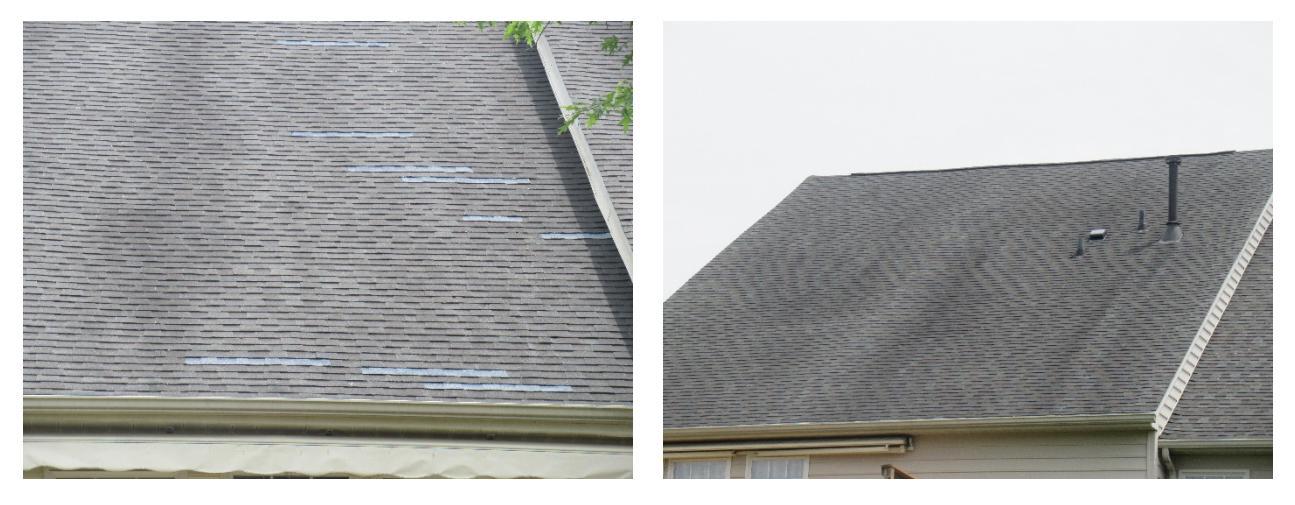
Roof overview- Note previous repairs

**Roof overview**

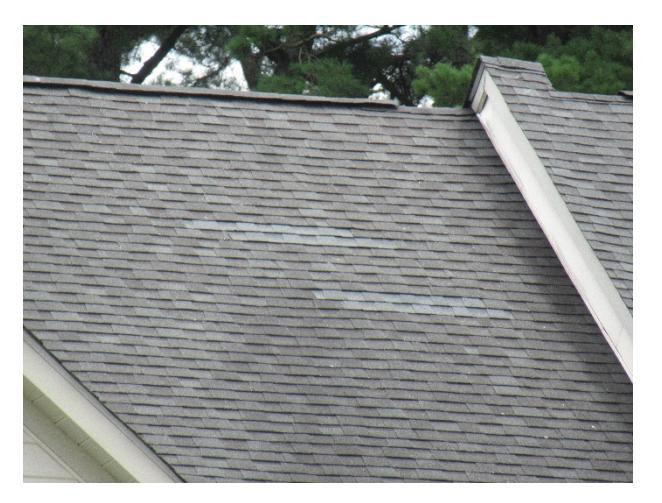
**Roof overview- Note previous repairs**

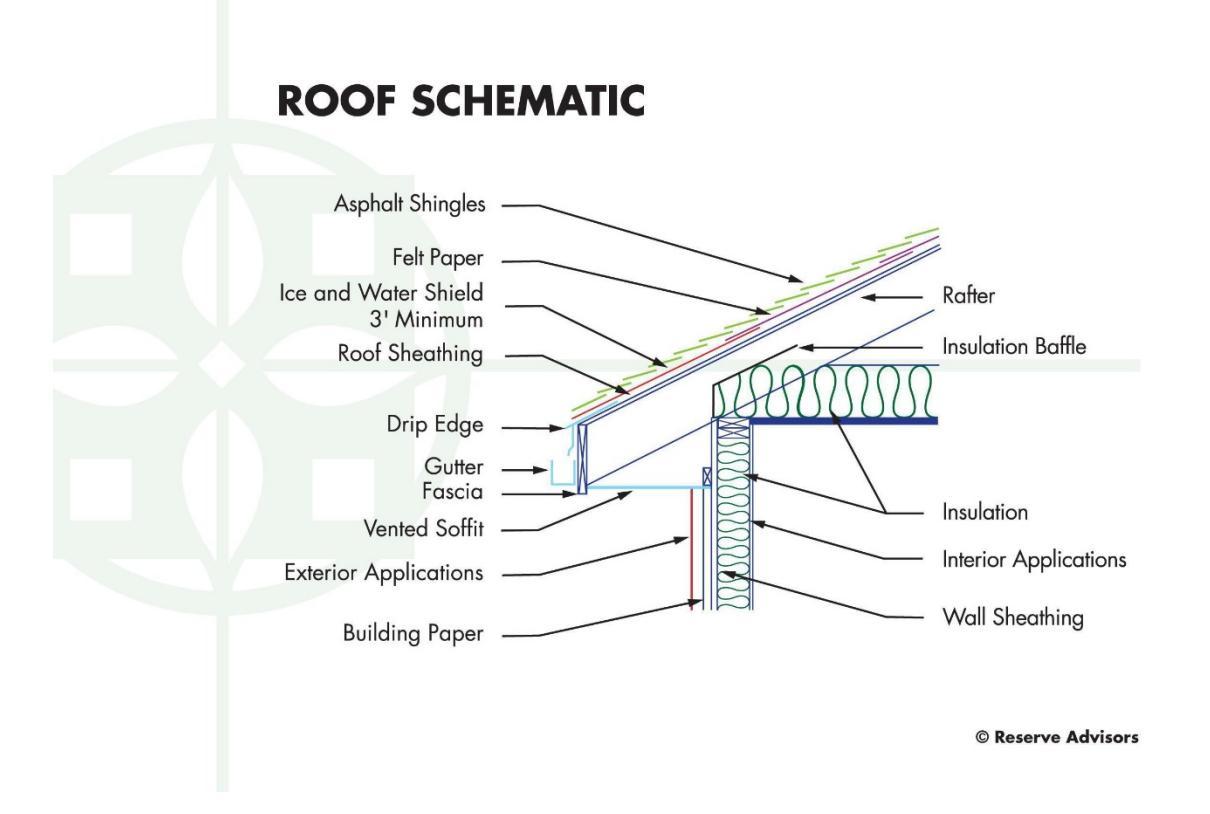
The following cross-sectional schematic illustrates a typical asphalt shingle roof system although it may not reflect the actual configuration at Hearthstone of Ellicott Mills:

Contractors use one of two methods for replacement of sloped roofs, either an overlayment or a tear-off. Overlayment is the application of new shingles over an existing roof. However, there are many disadvantages to overlayment including hidden defects of the underlying roof system, absorption of more heat resulting in accelerated deterioration of the new and old shingles, and an uneven visual appearance. Therefore, we recommend only the tear-off method of replacement. The tear-off method of replacement includes removal of the existing shingles, flashings if required and underlayments.

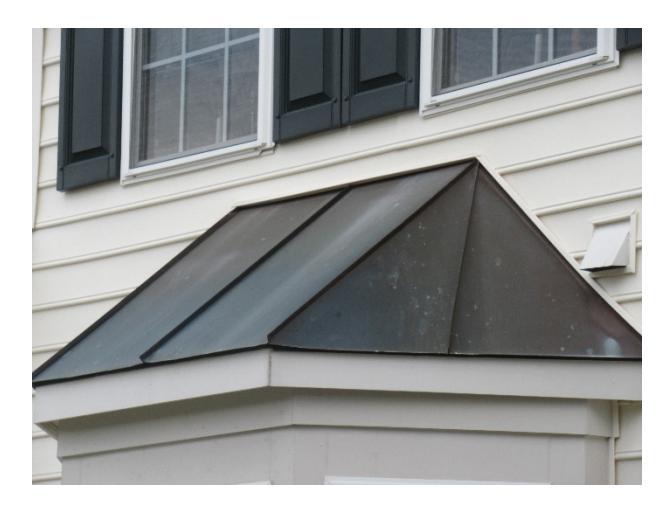
*Condition:* Good to fair overall with minor stains and wear evident from our visual inspection from the ground. Management and the Board do not report a history of leaks

Metal roof- Note minor stains

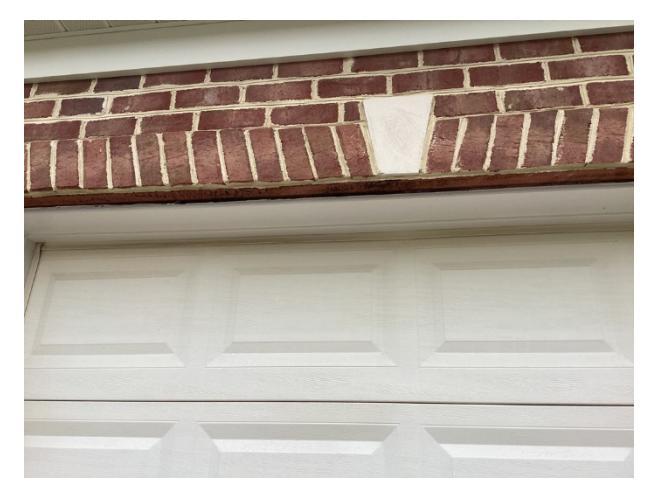
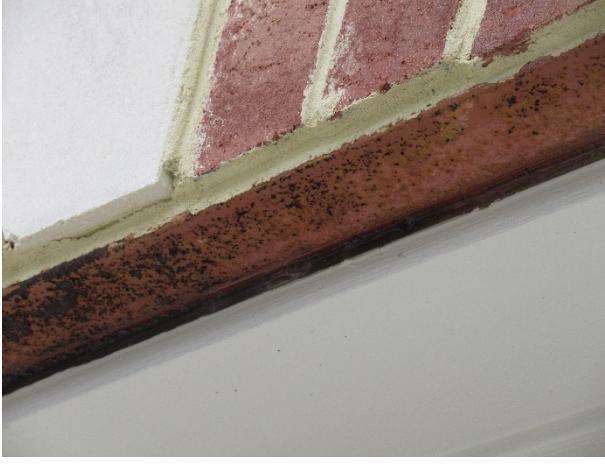
*Condition:* Good to fair overall with lintel deterioration and mortar deterioration evident.

Lintel deterioration

**Useful Life:** We advise a complete inspection of the masonry and related masonry repairs every 8- to 12-years to forestall deterioration.

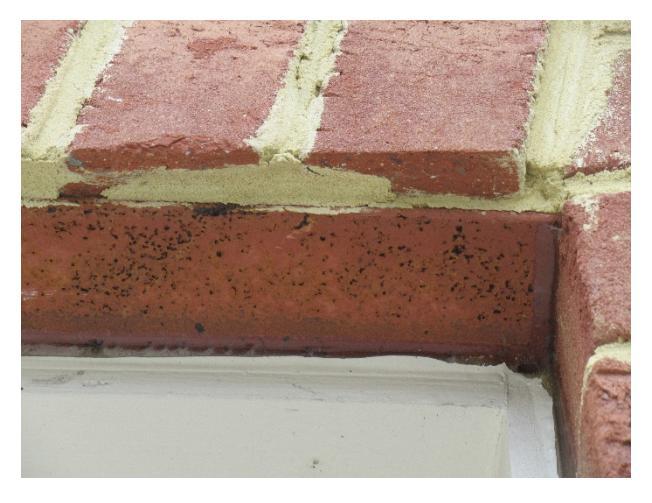
Lintel deterioration

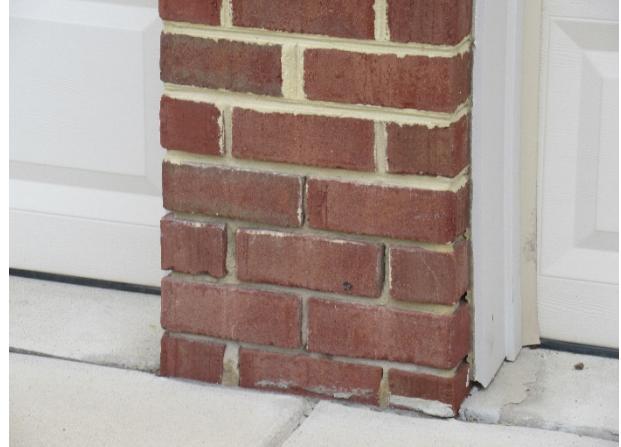
Mortar deterioration

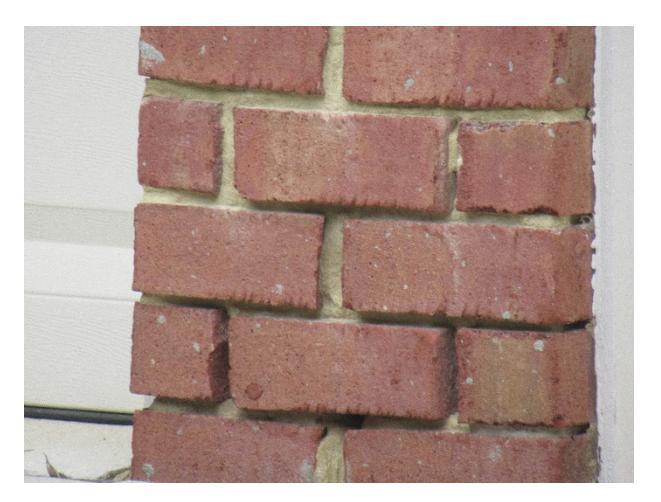
Mortar deterioration

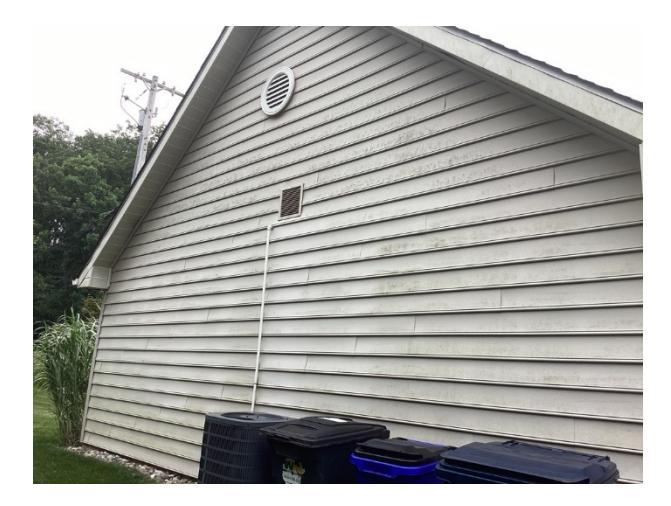
*Condition:* Good to fair overall with minor wear, warp and organic growth, most notably at the clubhouse.

Vinyl siding overview- Note organic growth and wear

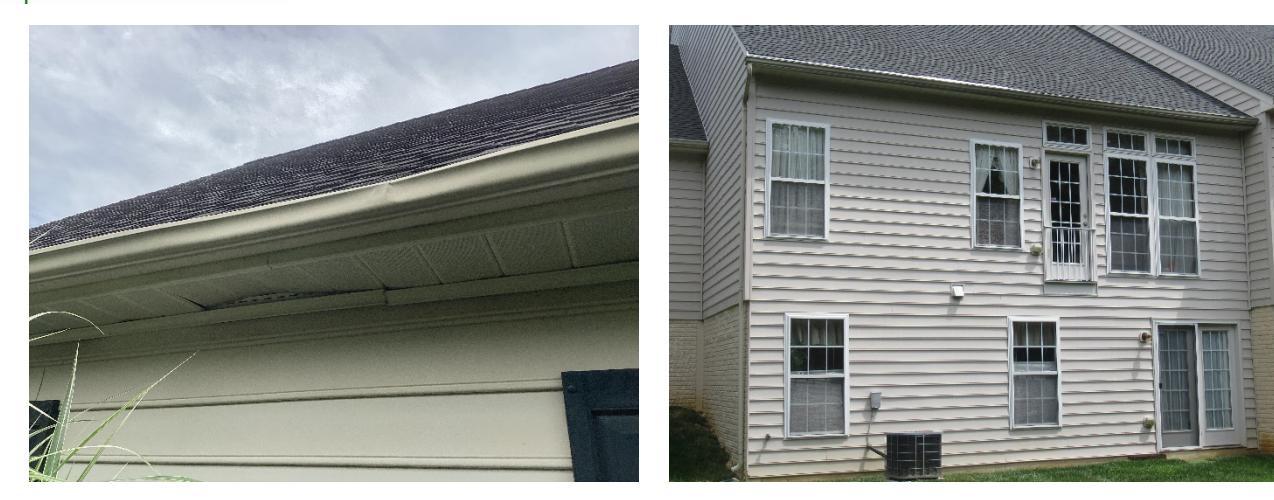
Damaged soffit and fascia

Vinyl siding overview

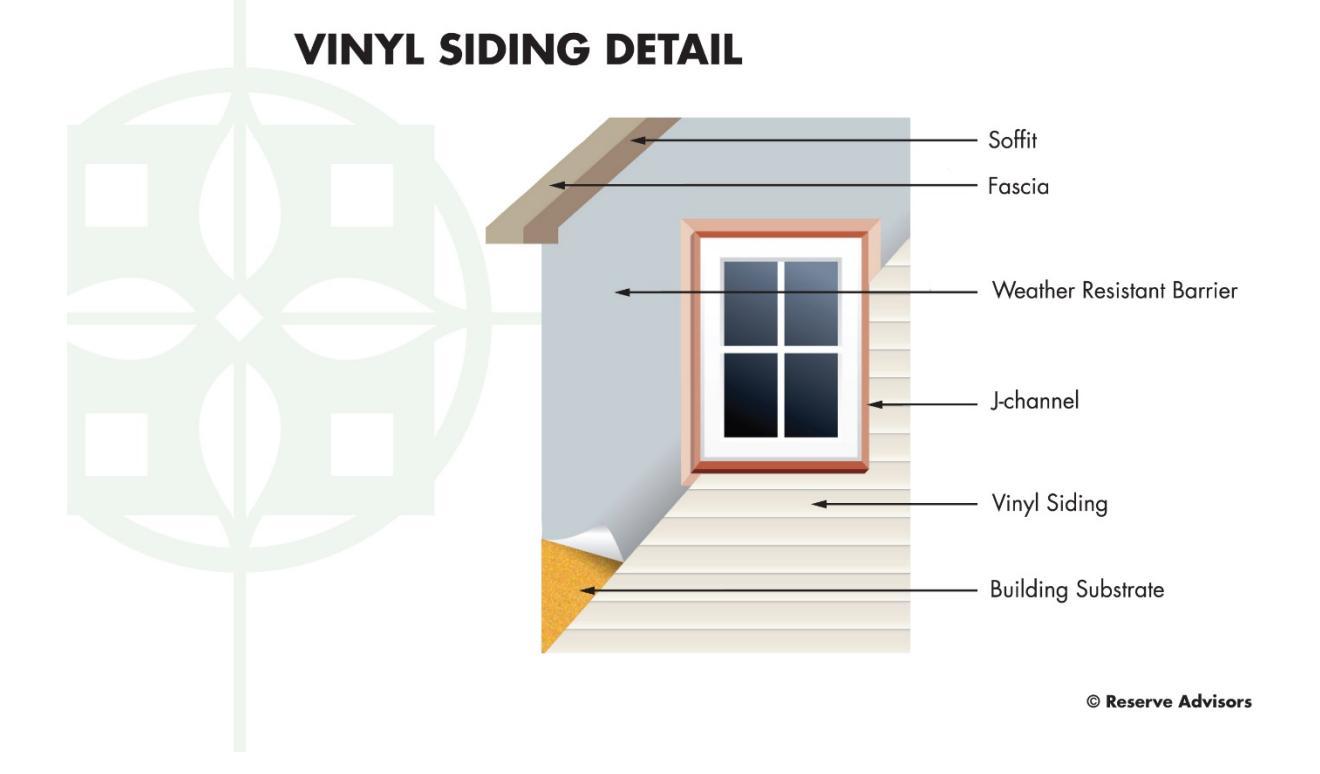
The following diagram details the use of building wrap in a vinyl siding system:

The Association should install new vinyl siding as recommended by the *Vinyl Institute, Inc.* The vinyl siding should be installed over a continuous weather resistant barrier and properly integrated flashing around all penetrations. Fasteners used should include aluminum, galvanized steel or other corrosion-resistant fasteners. Siding panels should overlap by approximately one inch. Joints should be staggered so that no two courses are aligned vertically, unless separated by at least three courses. The siding should not be caulked where the siding meets trim accessories, such as J-channel, or at overlap joints. J-channel should be installed a minimum of ½ inch off of roof lines.

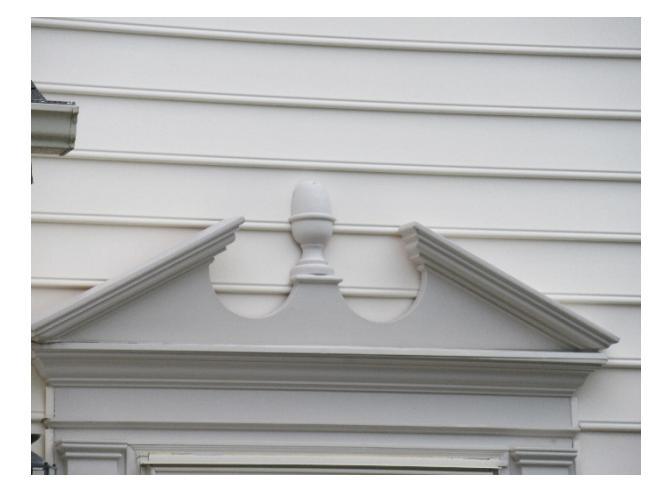
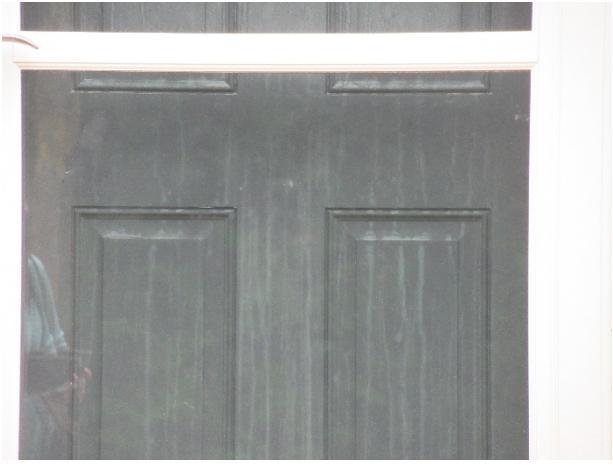
*Condition:* Good to fair overall with finish deterioration and wear, most notably at the front entrance doors and associated trim.

Trim overview

Painted door overview- Note deterioration

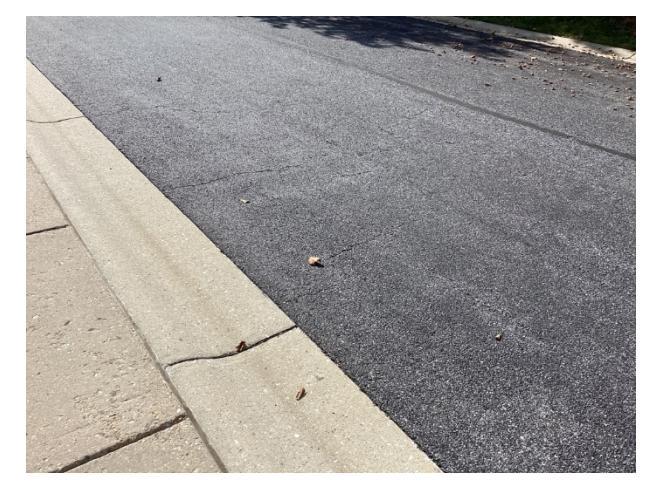
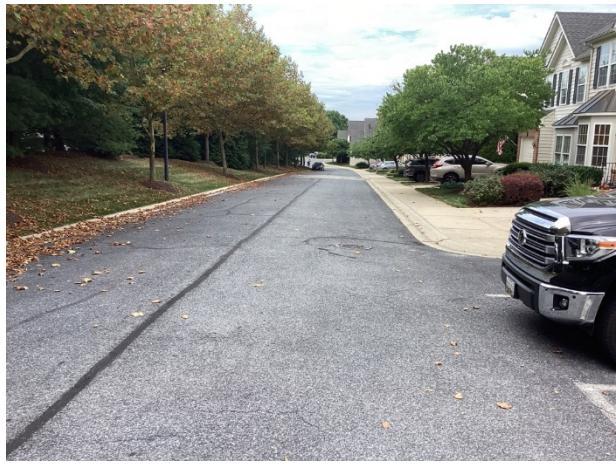
*Condition:* Good to fair overall with previous repairs and patches evident.

Asphalt pavement street overview- Note cracks

Asphalt pavement- Note previous repairs

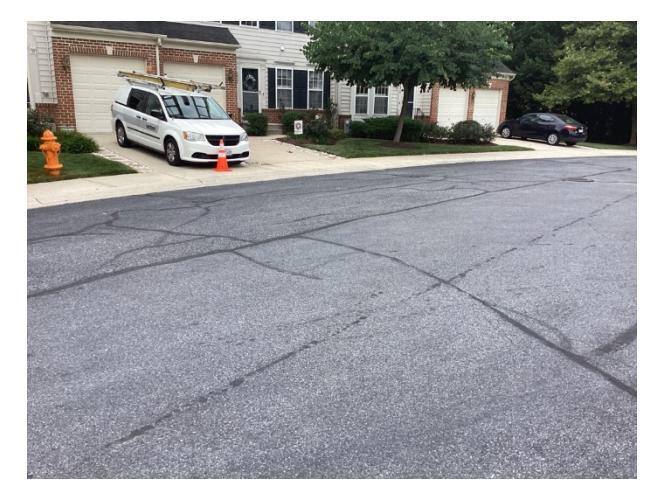
Asphalt pavement street overview- Note cracks

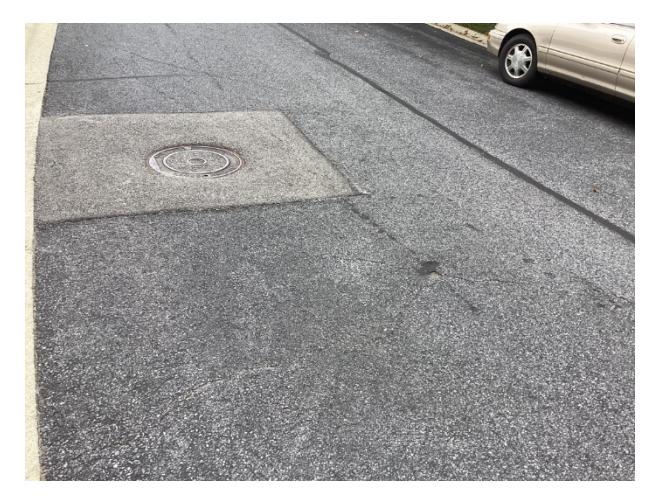
Asphalt pavement street overview- Note previous repairs

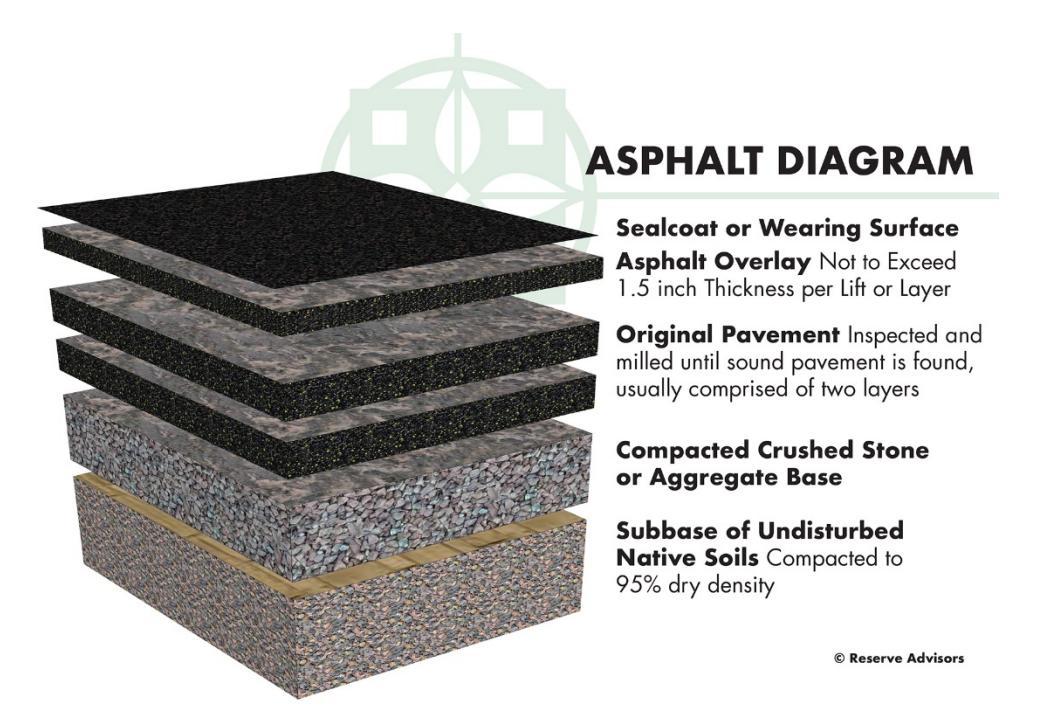
The second lift is the wearing course. The wearing course comprises a finer aggregate for a smoother more watertight finish. The following diagram depicts the typical components although it may not reflect the actual configuration at Hearthstone of Ellicott Mills:

The manner of repaving is either a mill and overlay or total replacement. A mill and overlay is a method of repaving where cracked, worn and failed pavement is mechanically removed or milled until sound pavement is found. A new layer of asphalt is overlaid atop the remaining base course of pavement. Total replacement includes the removal of all existing asphalt down to the base course of aggregate and native soil followed by the application of two or more new lifts of asphalt. We recommend mill and overlayment on asphalt pavement that exhibits normal deterioration and wear. We recommend total replacement of asphalt pavement that exhibits severe deterioration, inadequate drainage, pavement that has been overlaid multiple times in the past or where the configuration makes overlayment not possible. Based on the apparent visual condition and configuration of the asphalt pavement, we recommend the mill and overlay method of repaving at Hearthstone of Ellicott Mills.

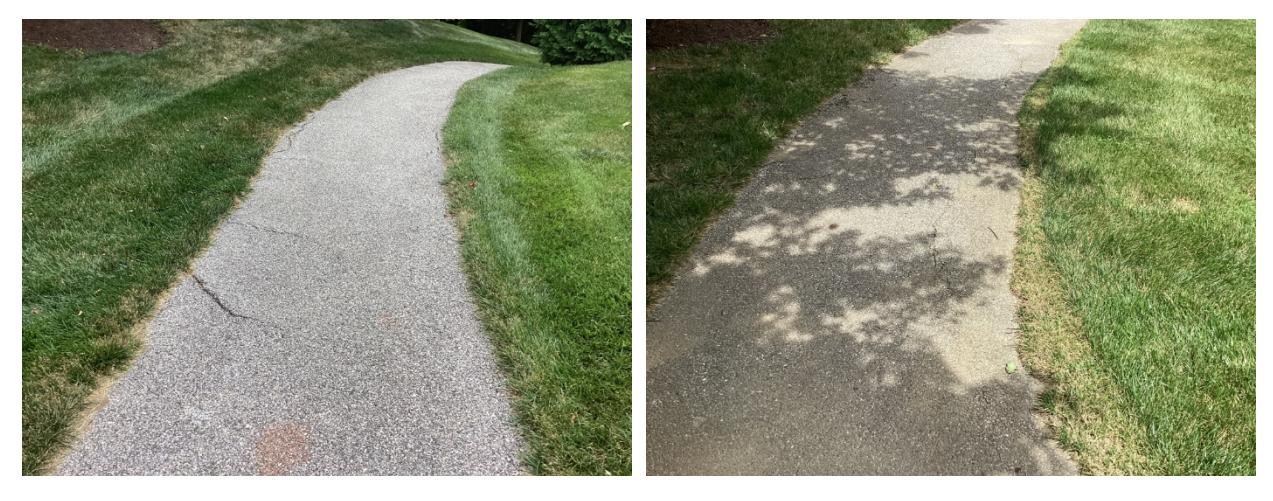
Walking path cracks

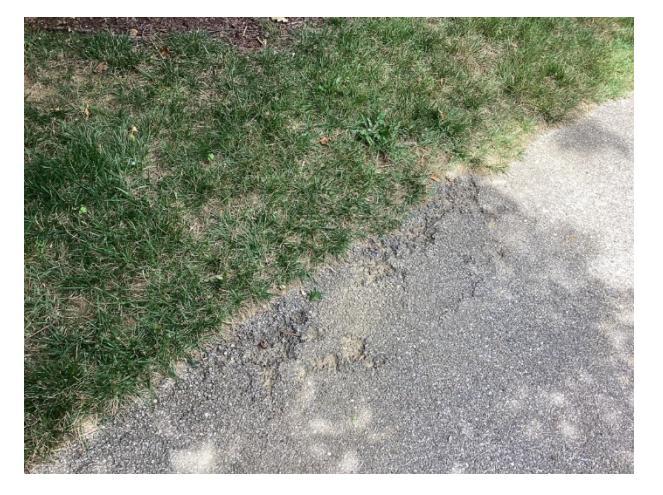
Walking path settlement

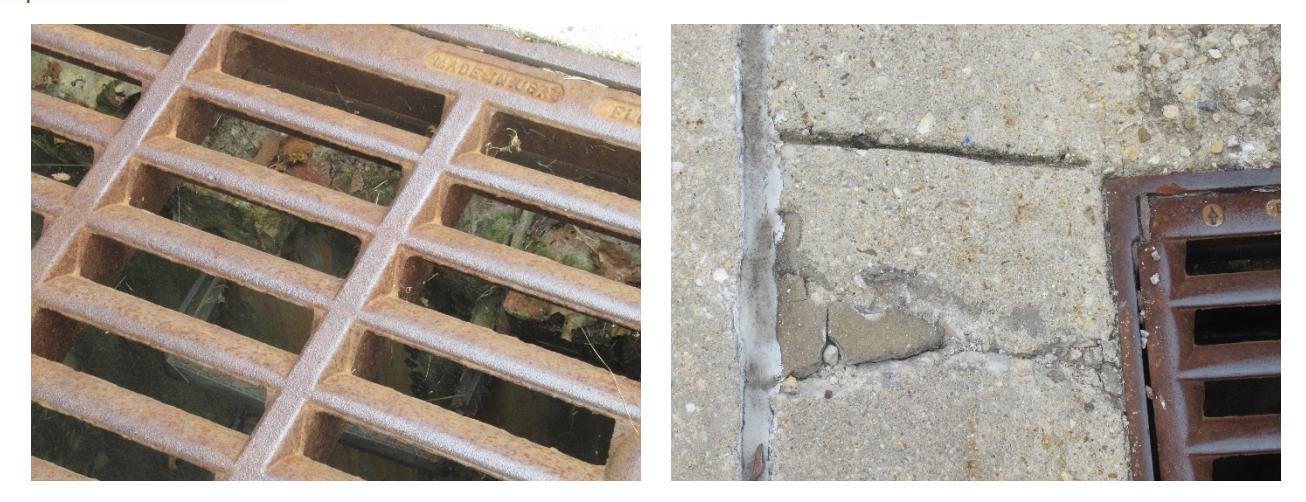
**Condition:** Good to fair overall with isolated settlement evident. We noted deteriorated masonry structures within the catch basins as noted by the recent catch basin inspection report.

Catch basin

Catch basin settlement

*History:* The Association reports that the catch basins were inspected in 2022. The Association repaired a majority of the catch basins in 2022 for a cost of \$14,500 and are planning to repair the remaining catch basins in 2023. Future updates to this study will consider the need for updated cost and timing if new information becomes available.

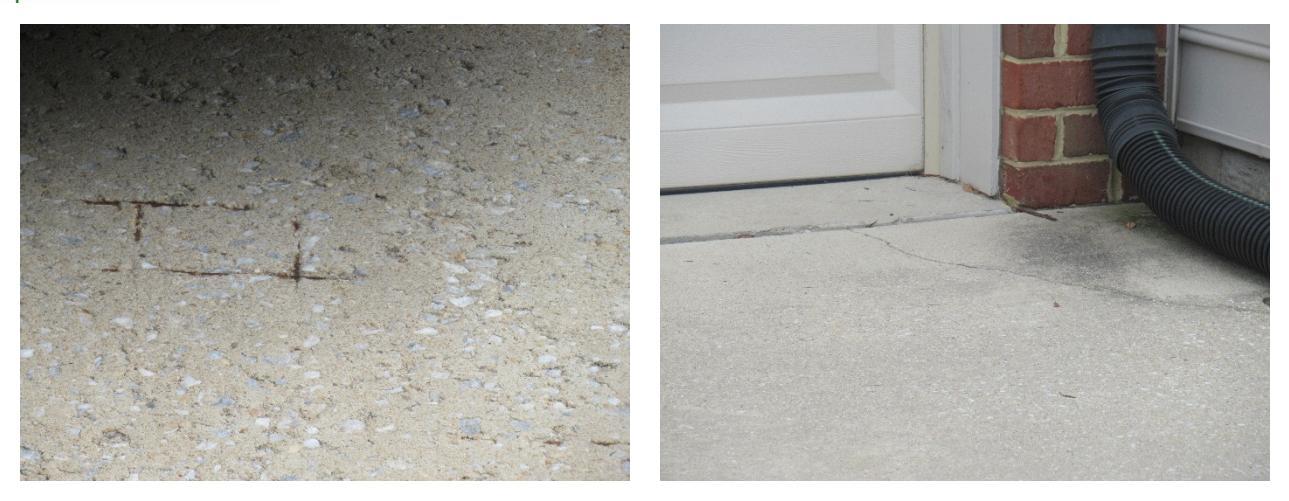
**Condition:** Good to fair overall with isolated cracks, delamination and scaling evident.

**Driveway deterioration located at Unit 4926**

**Driveway cracks**

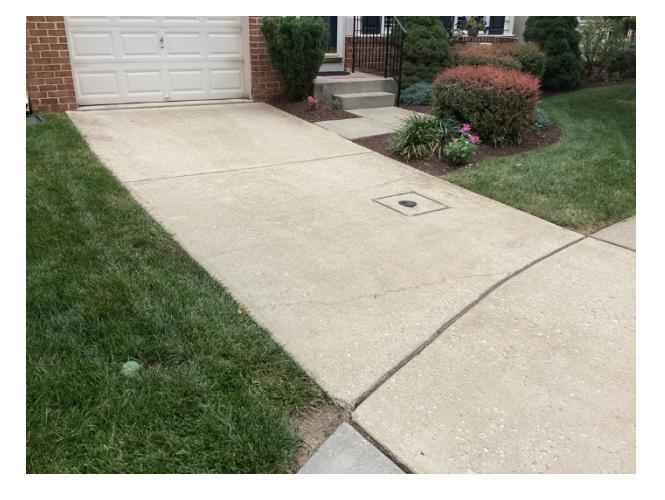
**Driveway cracks**

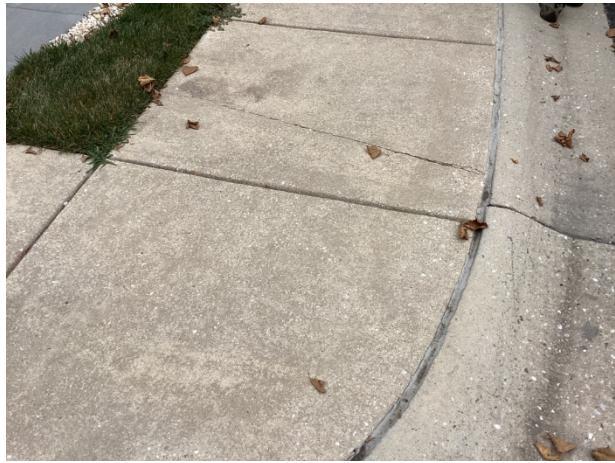
*Condition:* Good to fair overall with isolated cracks and spalling evident.

Sidewalk cracks

*History:* The Association contracted with Concrete Slap Jacking in September 2022 to repair over 20 areas within the community to level the concrete and remove trip hazards and other repairs to the concrete at a cost of \$4,777.

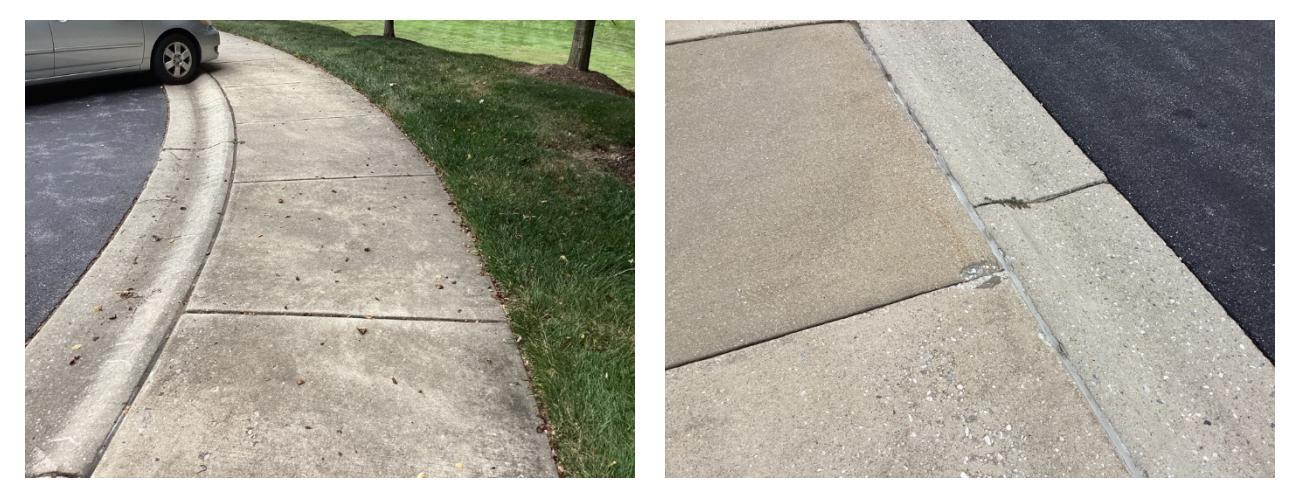
Concrete sidewalk

Sidewalk spalls

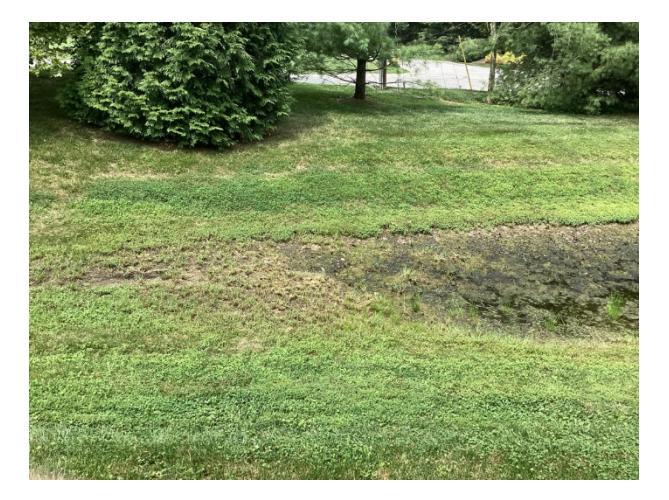
*Condition:* Good to fair overall with sediment build-up and algae blooms evident.

**Minor shoreline erosion**

**Useful Life:** Based on the visual condition, we recommend the Association anticipate the need for capital repairs to the stormwater management up to every three- to five-years.
